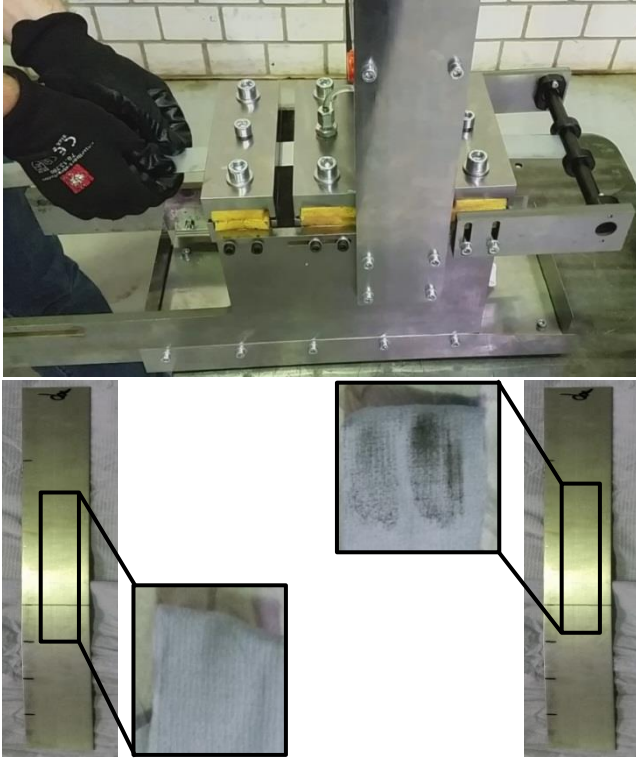
Fig. 3: Cleaning station without air nozzles (upper picture); wipe test before cleaning (bottom right picture); wipe test after cleaning (bottom left picture)

The wipe test, depicted in Fig. 3, shows the presence of significant macroscopic contamination of the sheet metal before cleaning. This can be attributed to the prelube oils which are used in commercial sheet metal production for corrosion protection. The wipe test in the left bottom picture shows a macroscopically clean sheet metal surface after passing the cleaning station within the first three cleaning steps. During the investigations the fresh material was continuously cleaned in the cleaning station. The cleanliness of the sheet metal surface was regularly manually checked with wipe tests. In case of detectable contaminations, the sponges of the station were cleaned or if necessary renewed.
